SI B51 05 14
Body Equipment

May 2014
Technical Service

Service Action: Remove and Discard Water Drain Plugs from E-Box

F30 (3 Series)

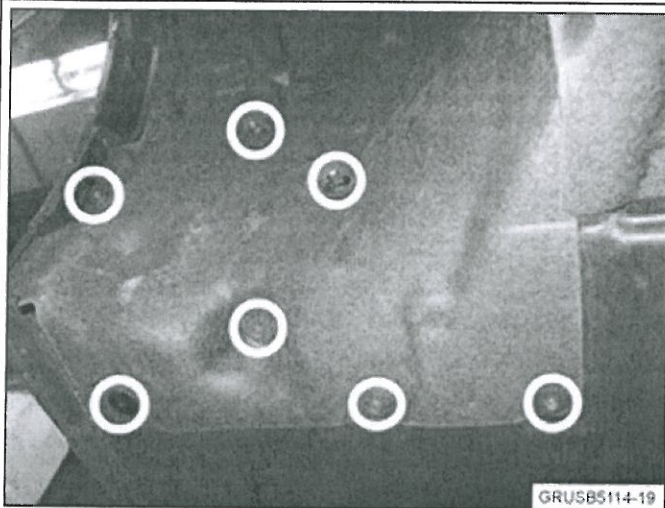
Note: The picture is of the front passenger's side wheel house trim.

2. Remove the seven fasteners as shown.

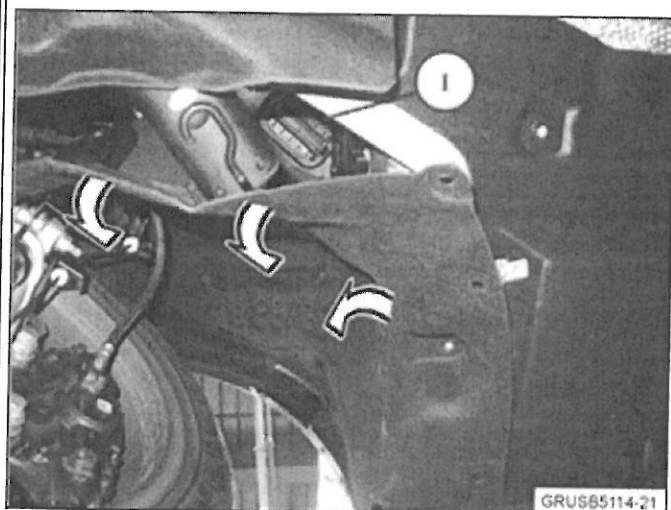
4. Pull the wheel house trim down partially to expose the drain plug. The picture shows the oval E-box drain plug (1) from underneath the vehicle.

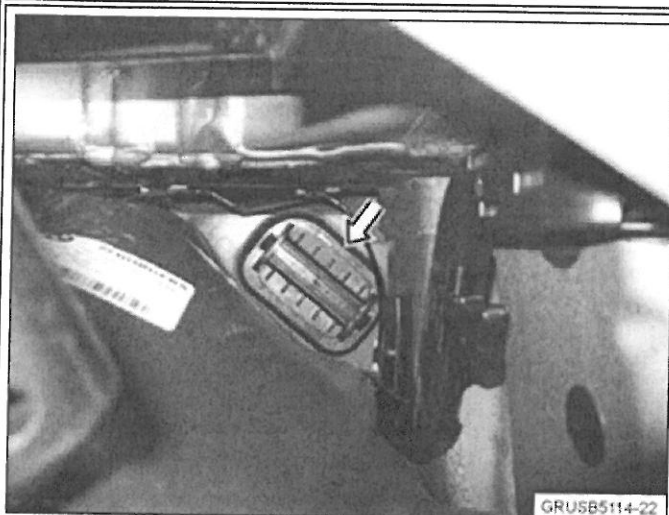
Water leaks into the cabin due to clogged drain plugs in the E-boxes.

The drain plug slots are too small and clog.

5. To remove the drain plug, follow the arrow direction and pull out downwards. Discard the drain plug.

With the drain plug removed, check inside the E-box body opening and remove any debris.
