BMW F80 M3 Sedan / Repair Manuals and Technical Data / 51 Body equipment / 51 43 Side Trim Panel with Armrests /

## 51 43 251 Removing and installing or replacing trim panel for left or right rear roof pillar (C-pillar)

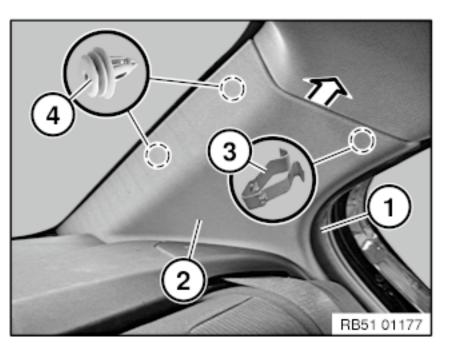
Detach edge protection (1) in area of trim panel (2).

Release trim panel (2) from first detent position of clamp (3).

Release trim panel (2) from upper clip (4).

Pull off trim panel (2) in direction of arrow, with lower clip (4) remaining on the C-pillar.

Lever out clip (4) remaining in C-pillar and insert in trim panel (2).

Make sure <u>edge protection</u> (1) is correctly seated on trim panel (2).

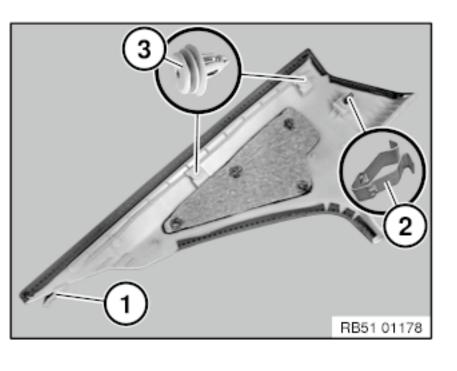
Guide (1) must not be missing or damaged.

Replace faulty clamp (2) and clip (3).

Check that clamp (2) is securely seated in trim panel, replace if necessary.
