Original BMW Accessories. Installation Instructions.

BMW M Performance Sports Chassis Retrofit

BMW 1 Series 5-door (F20)

BMW 3 Series Saloon (F30)

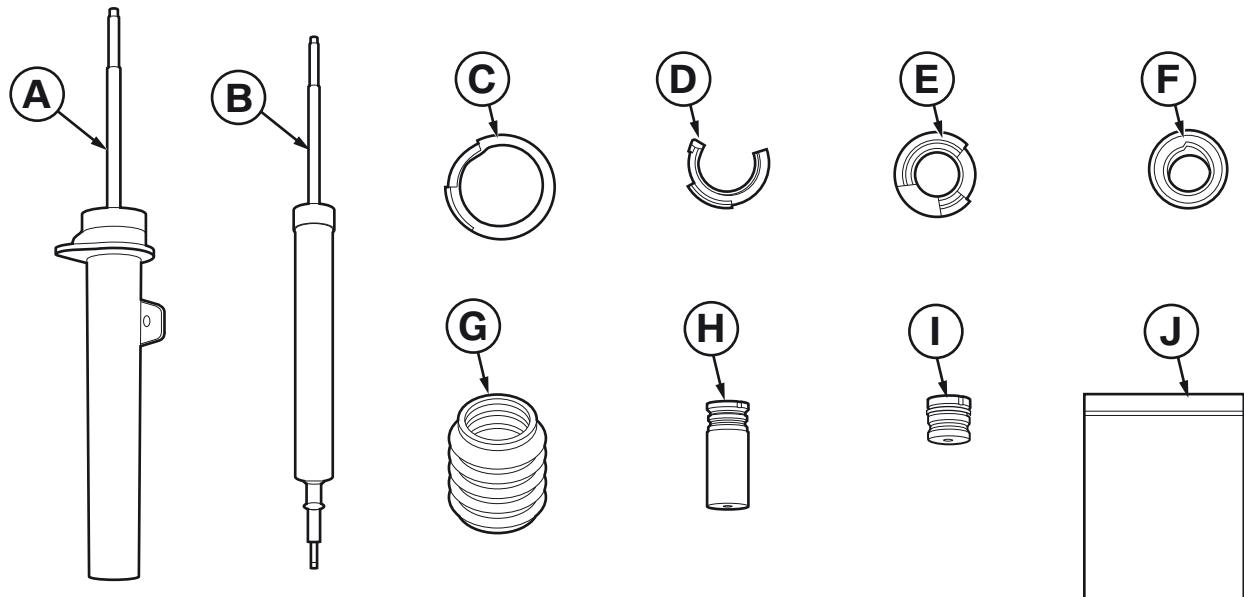
F20 0132 V

1. BMW M Performance Sports Chassis F20 and F30 (4-cylinder/6-cylinder) parts list

- A** Front spring strut (2 x)
- B** Rear shock absorber (2 x)
- C** Front lower spring support (2 x)
- D** Front upper spring support (2 x)
- E** Rear lower spring support (2 x)
- F** Rear upper spring support (2 x)
- G** Protective pipe (2 x)
- H** Rear auxiliary shock absorber (2 x)
- I** Front auxiliary shock absorber (2 x)
- J** Various fastening parts
